YOUR ONESURVEY
HOME REPORT

Flat 29 37
Pilrig Heights
Edinburgh
EH6 5FB

SINGLE SURVEY

Single Survey

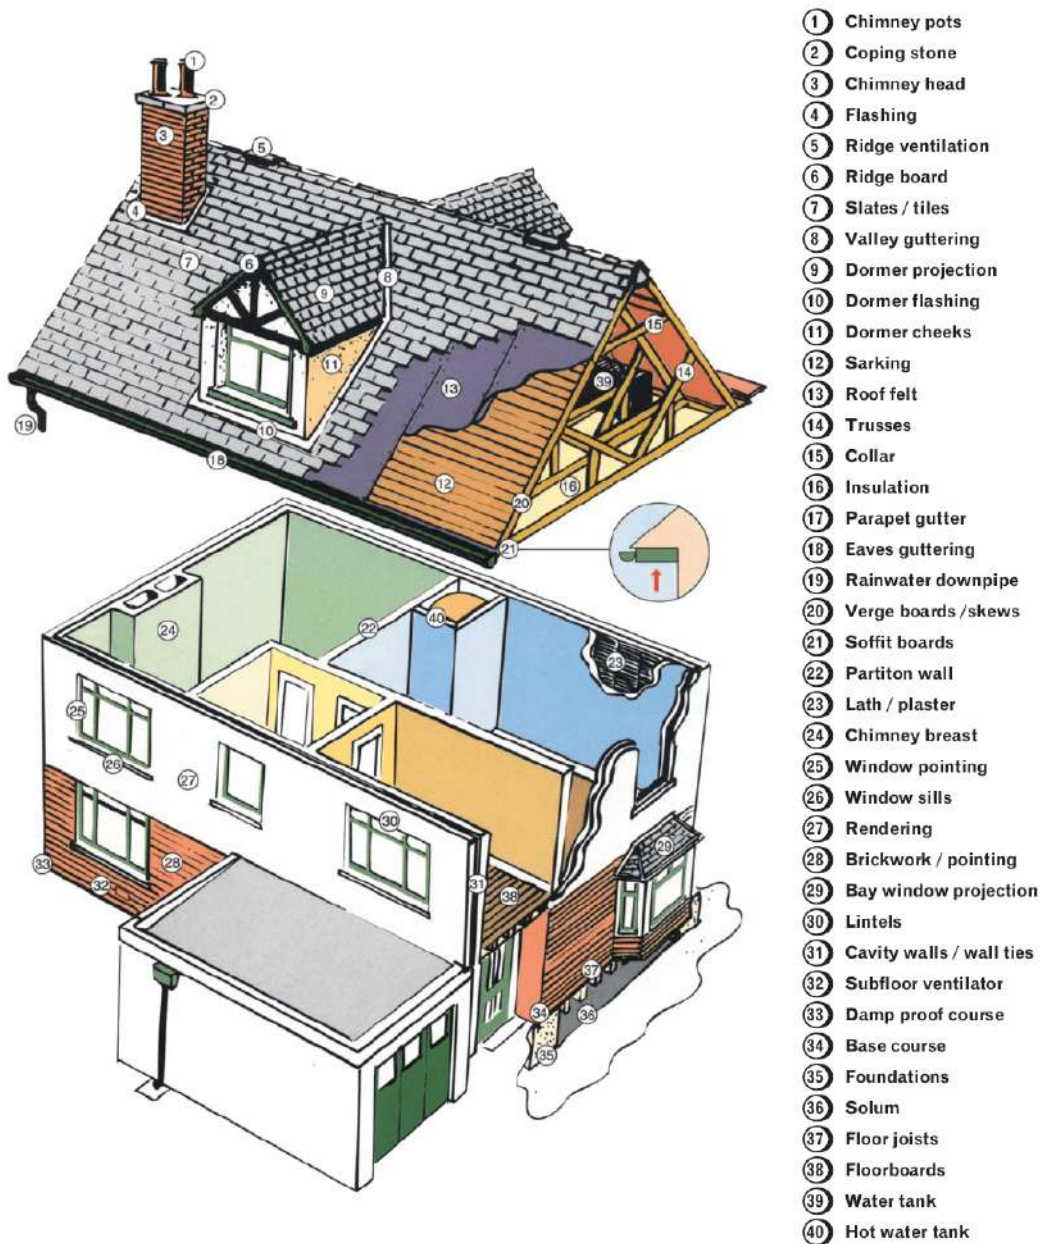
Sectional Diagram showing elements of a typical house

Reference may be made in this report to some or all of the above component parts of the property. This diagram may assist you in locating and understanding these items.
